Manhole Inspection Summary

Manhole # S41G__014MH

Insp Date: **12/22/08 12:16 PM**

Location Address: **rear 837 s monford st**

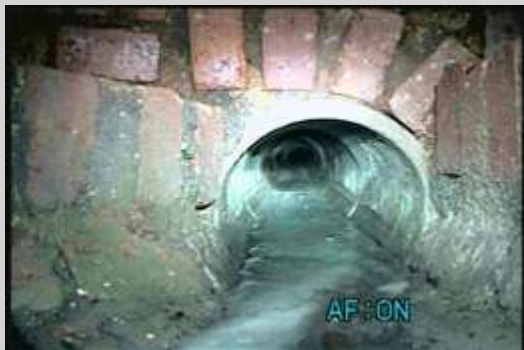
12 O'Clock Outflow

Invert Depth: **9.33** (ft.) Flow Characteristics: **Fast**

Infiltration: **None** Pipe Seal Cond: **Unknown**

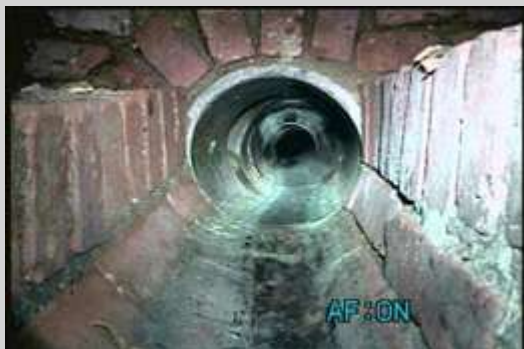
6 O'Clock Inflow

Invert Depth: **9.10** (ft.) Flow Characteristics: **Fast**

Infiltration: **None** Pipe Seal Cond: **Unknown**

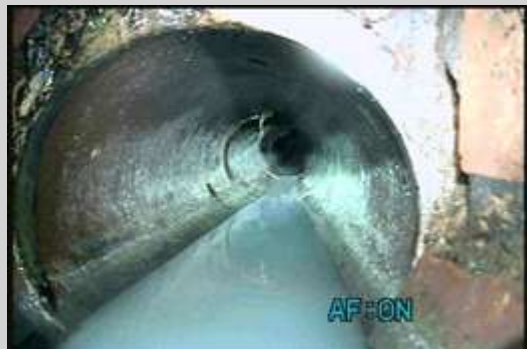
9 O'Clock Inflow

Infiltration: **None** Pipe Seal Cond: **Unknown**
